Failure analysis of weld cracking of gas gathering pipeline in dewatering station

Yong Chen^{1,2*}, Yi Xie¹, Wenjing Wang³ and Jichuan Li⁴

Keywords: Gas gathering pipelines, Weld, Failure analysis, CFD simulation

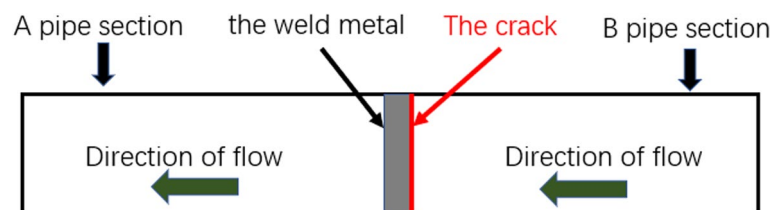
Fig. 1 Schematic diagram of A and B pipe sections

External inspection and measurement of the pipe showed no obvious signs of corrosion pits inside or outside the pipe (Fig. 1). In the direction of 12 o'clock position, on the outer surface of the pipe near the side of the B pipe section, there is a crack that extends along the circumference of the weld with a crack length of about 40 mm and corresponds to the presence of a circumferential crack of about 140 mm in length and 0.46 mm in width on the inner surface of the weld. As shown in Fig. 2.

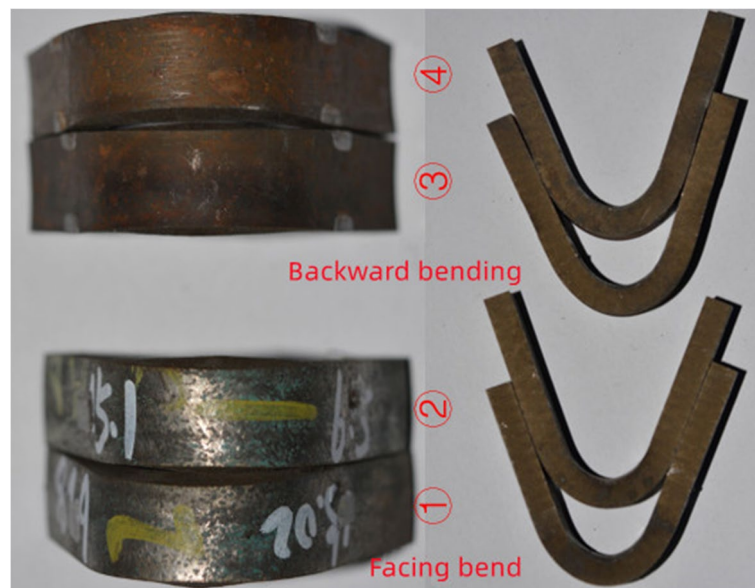
Fig. 3 Specimen after bend testing experiment

according to the standard *GB / T232-2010 Metal material bending test method*. The experimental data are shown in Table 7. The standard *GB/T9711-2017 steel pipe for pipeline transportation system of petroleum and natural gas industry* stipulates that no crack should appear in any part of the sample after the bending test. The samples after the test were observed and analyzed. There were no cracks in any position of the experimental samples after the test, as shown in Fig. 3. The results show that the bending performance of the pipe meets the standard requirements.

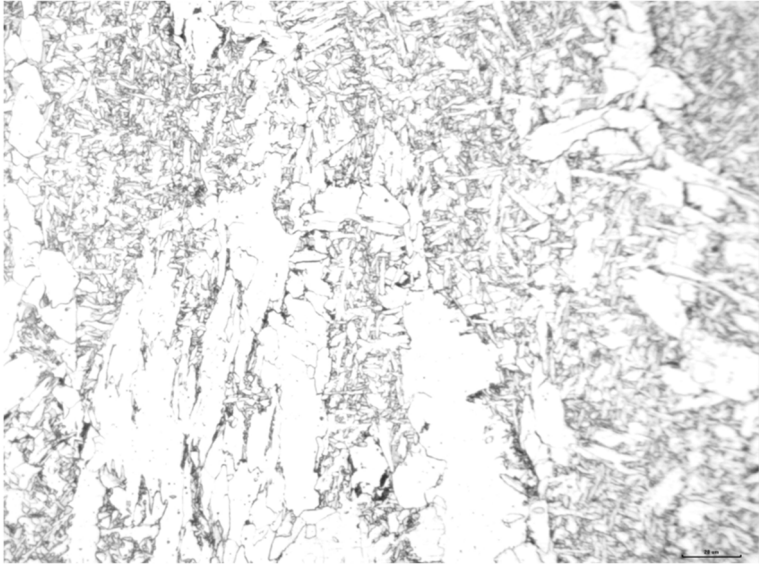
Fig. 4 Structure of filling layer of girth weld

The girth weld metal of the metallographic specimen without crack is acicular ferrite + granular bainite + polygonal ferrite + pearlite structure (Fig. 4), the microstructure in the weld root is polygonal ferrite + pearlite (Fig. 5), the fusion zone structure is granular bainite + polygonal ferrite + pearlite structure (Fig. 6), and the structure in the fine grain zone is polygonal ferrite + pearlite (Fig. 7). No welding defects such as inclusions, holes, or unfused metal are found.

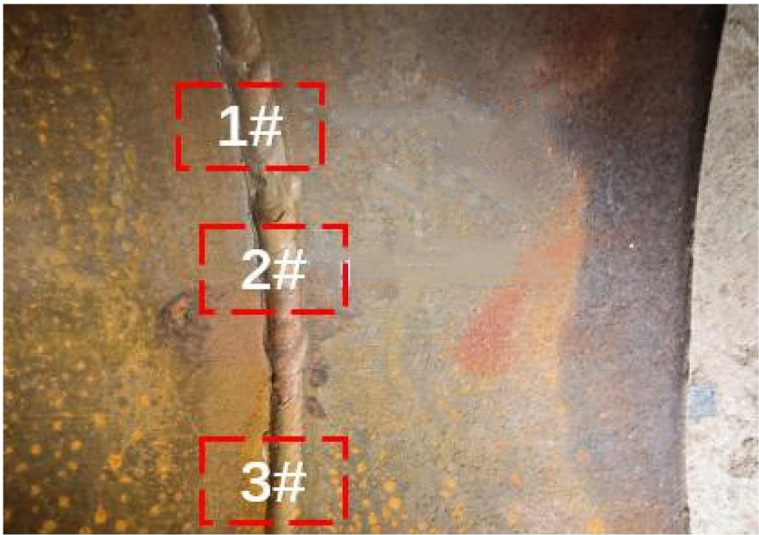
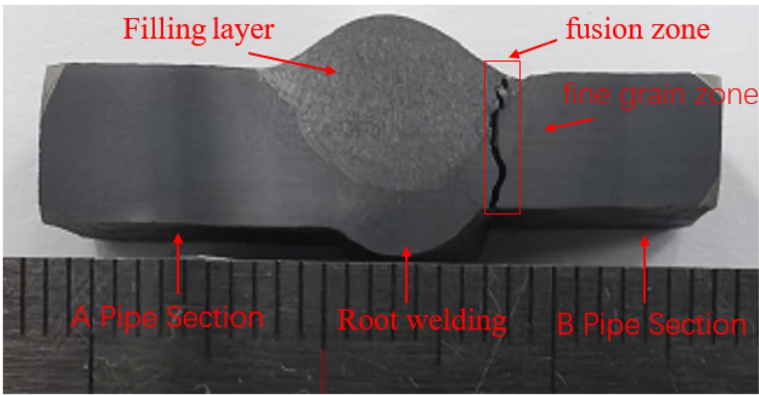
Fig. 8 Sampling position of cracked girth weld

Fig. 9 Failure weld

Three samples were taken at the cracking position of the girth weld to carry out metallographic analysis. The sampling positions are shown in Figs. 8 and 9, and the analysis results are summarized in Tables 11 and 12.

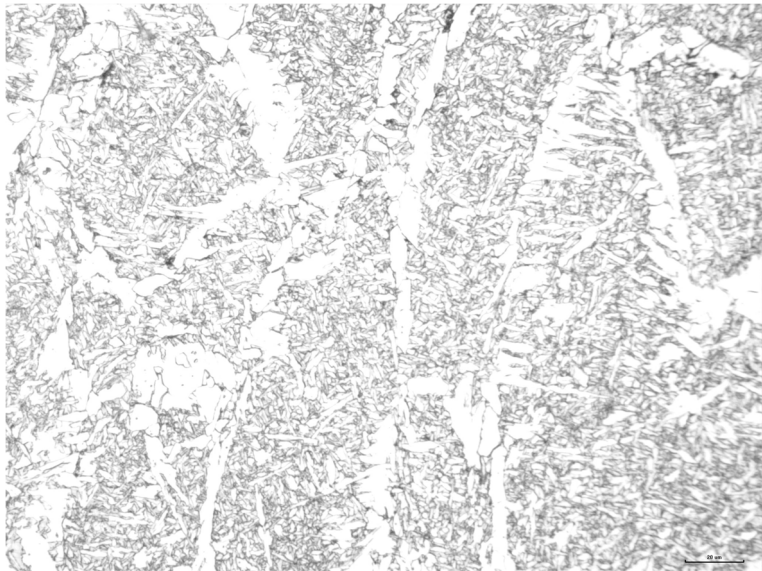
Fig. 10 Structure of filling layer of failed girth weld

The microstructure of the filling layer of the cracked girth weld metallographic sample is acicular ferrite + granular bainite + polygonal ferrite + pearlite (Fig. 10), and the structure at the root of the weld is polygonal ferrite + pearlite (Fig. 11), the fusion zone structure is granular bainite + polygonal ferrite + pearlite (Fig. 12), the

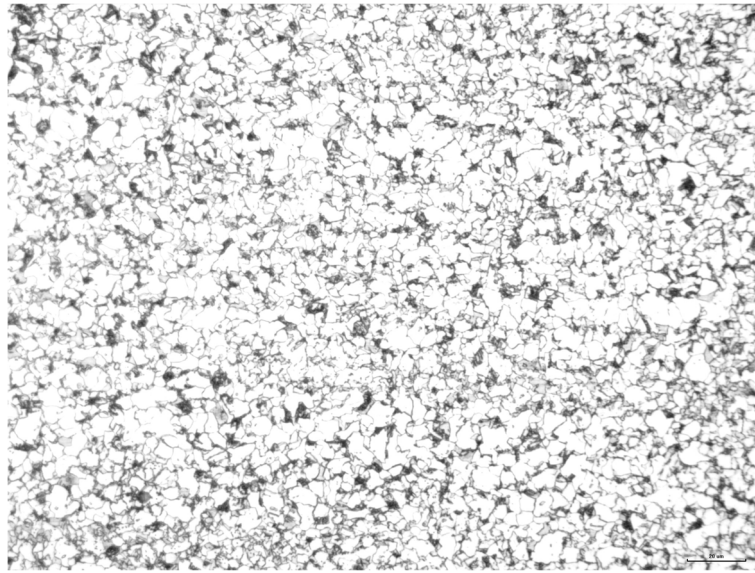
Fig. 13 Structure of fine-grained region

fine-grained zone structure is polygonal ferrite + pearlite structure (Fig. 13), and no abnormal structure is found.

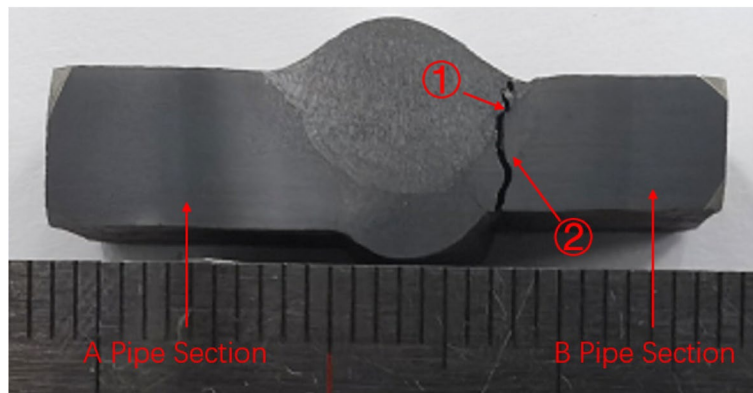
Fig. 17 Macro-morphology of 1# (the upper part is the outer surface)

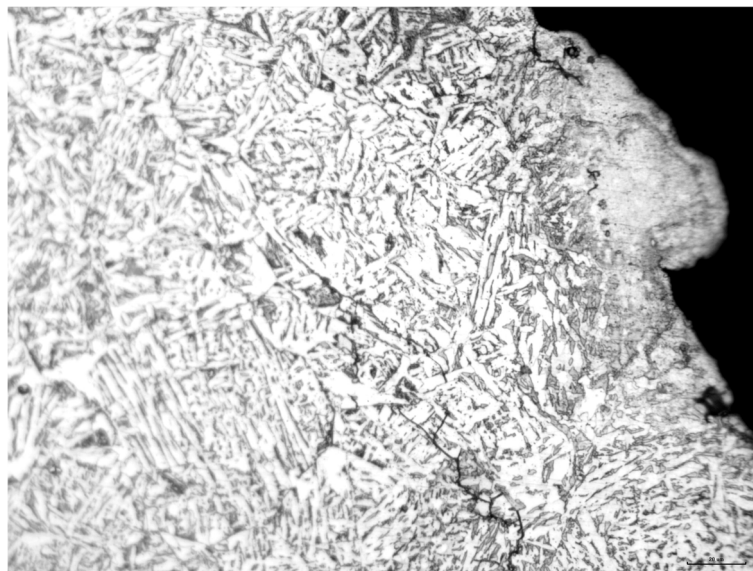
Fig. 18 Macro-morphology of 1# crack (position ① in Fig. 17)

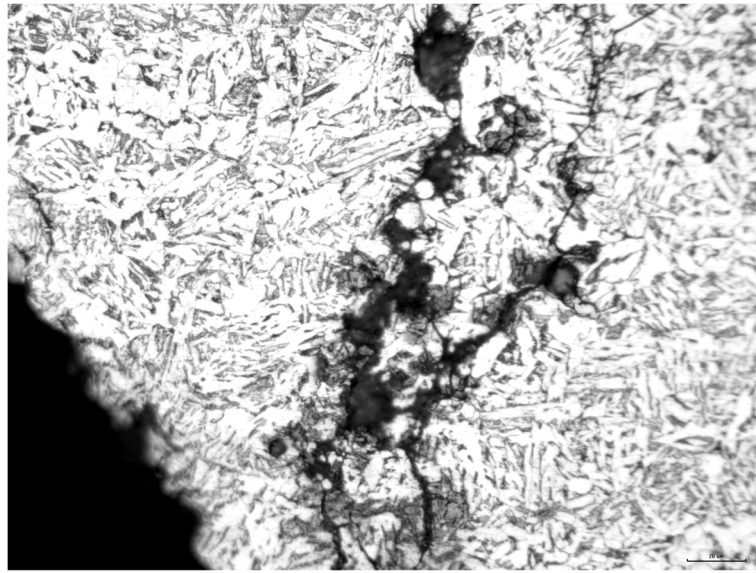
Fig. 19 Macro-morphology of 1# crack (position ② in Fig. 17)

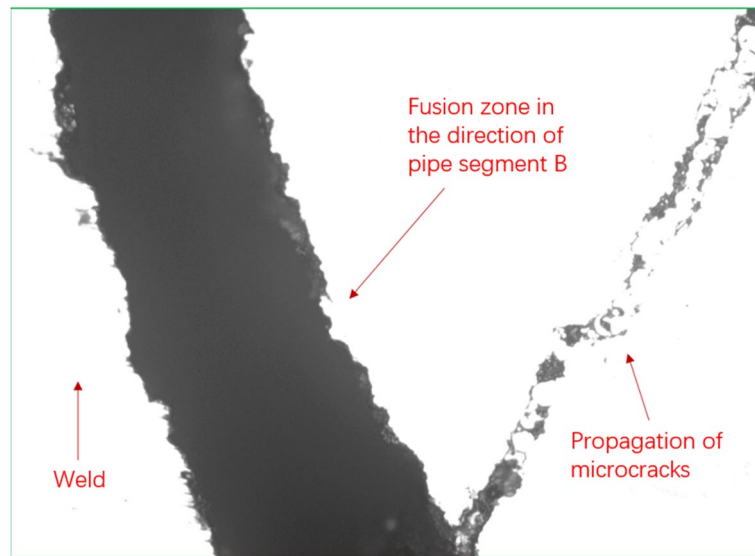
Fig. 21 Section 2 at the crack of 1# (left side of position ① in Fig.17)

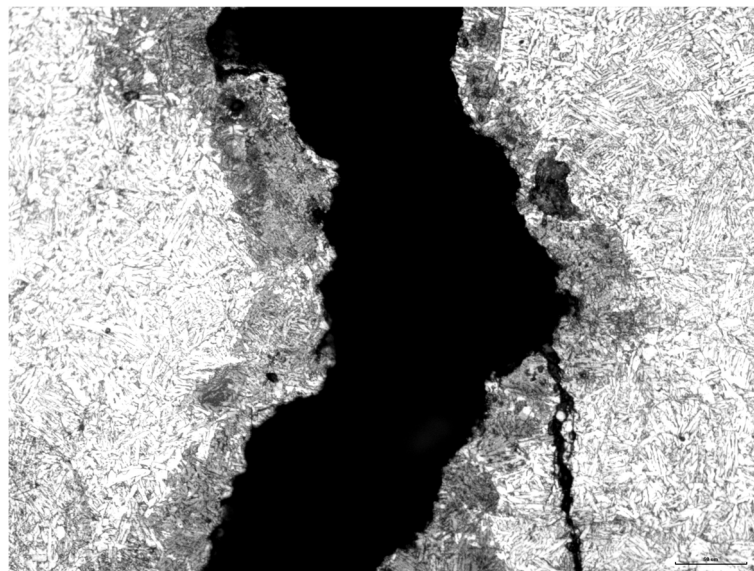
Fig. 22 Section 3 of the crack at 1# (position ② in Fig. 17)

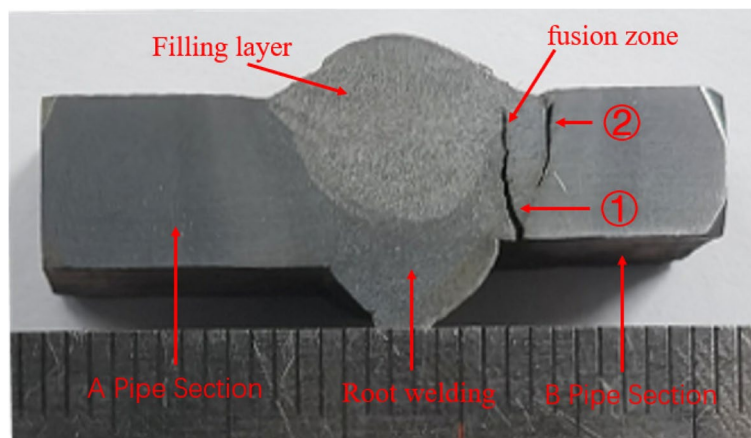
Fig. 23 Macroscopic appearance of 2# (the top is the outer surface)

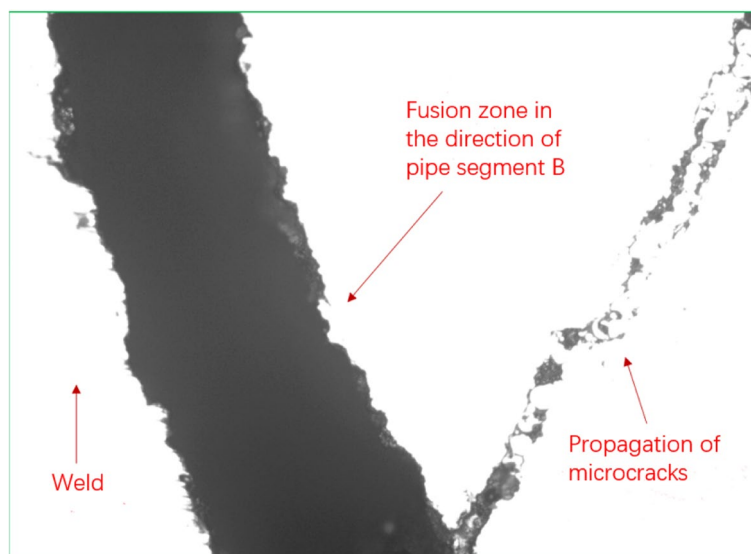
Fig. 24 Macroscopic appearance of 2# crack

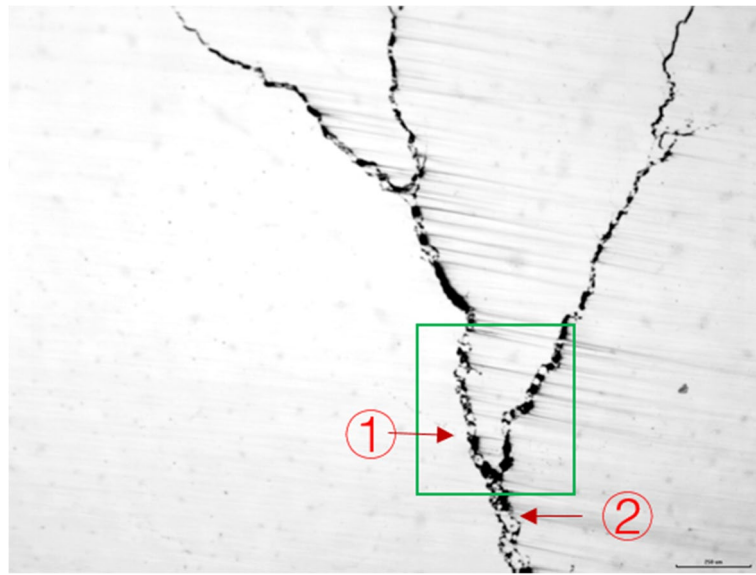
Fig. 25 Section 1 at the crack of 2# (position ① in Fig. 23)

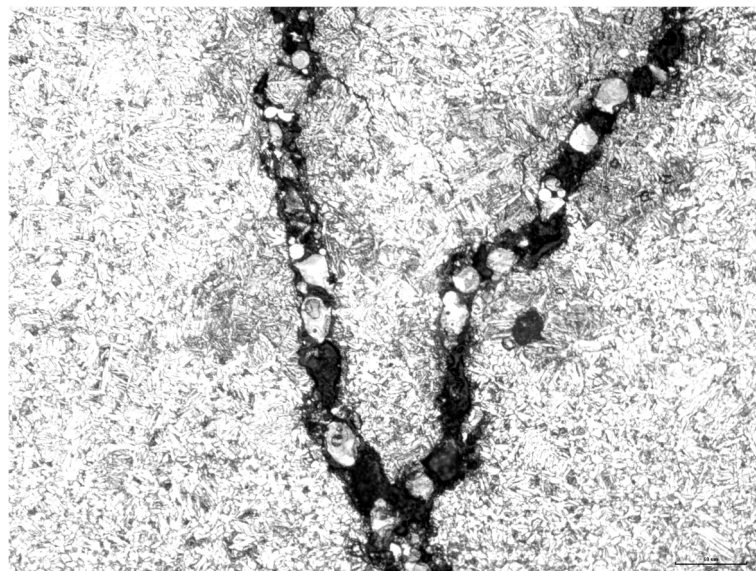
Fig. 26 Section 2 at the crack of 2# (position ② in Fig. 23)

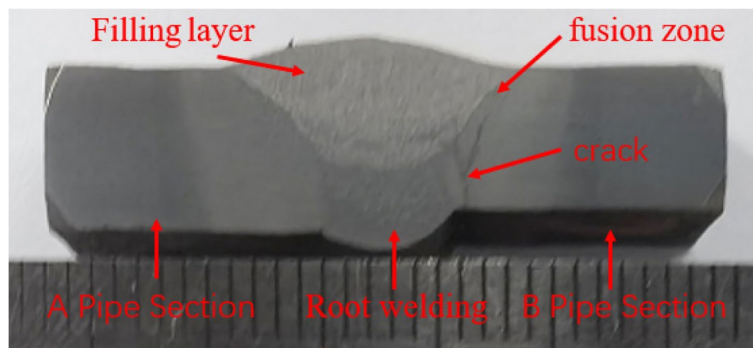
Fig. 27 Macroscopic appearance of 3# (the outer surface above)

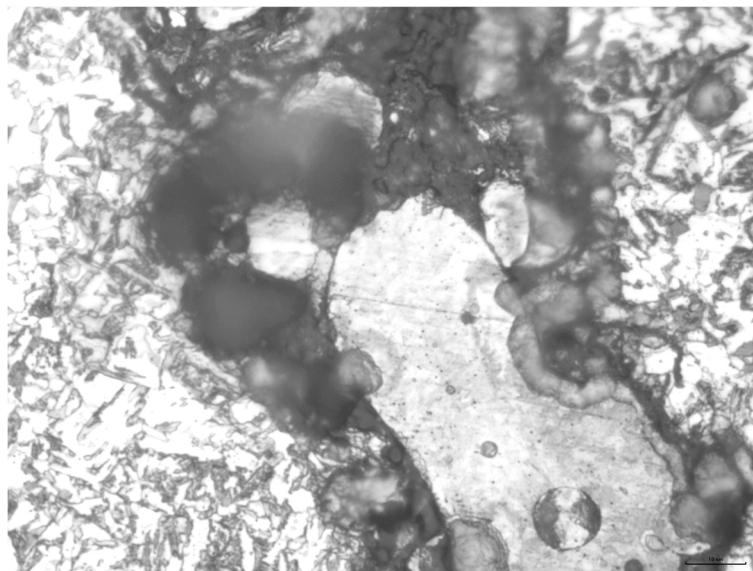
Fig. 28 Macroscopic appearance of 3# crack

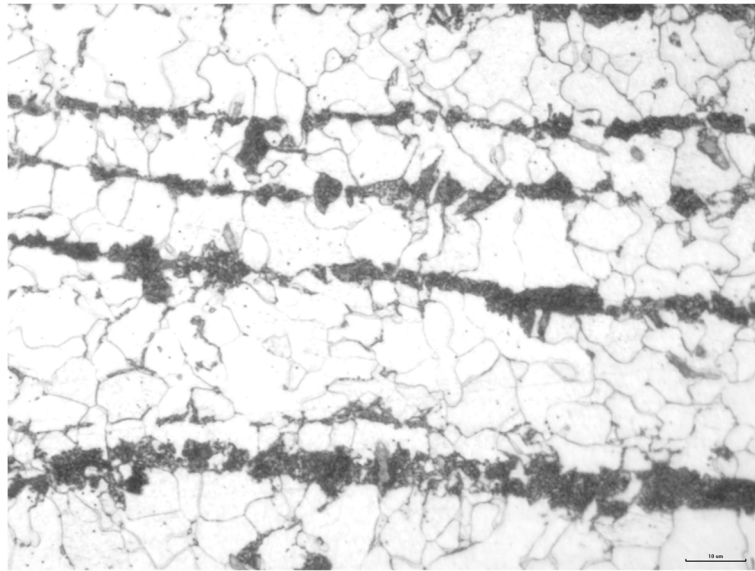
Fig. 29 Section 1 at the crack of 3# (the position of the green frame in Fig. 28)

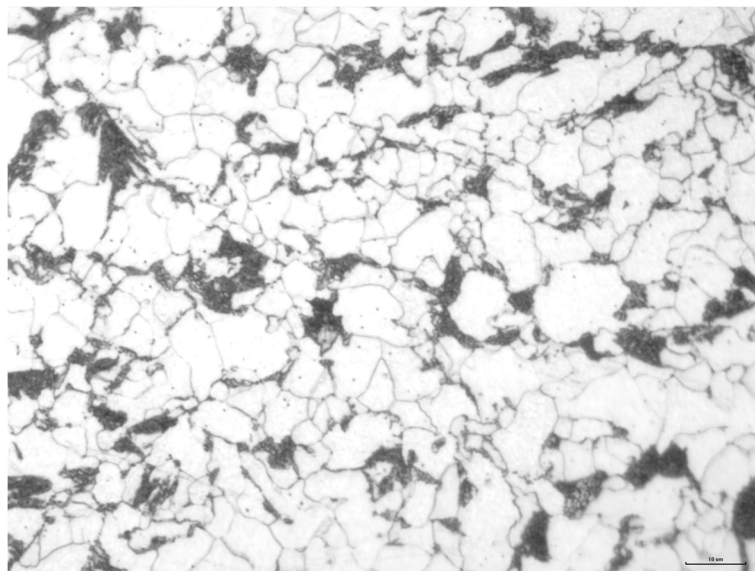
Fig. 30 Section 2 of the crack at 3# (position ① in Fig. 28)

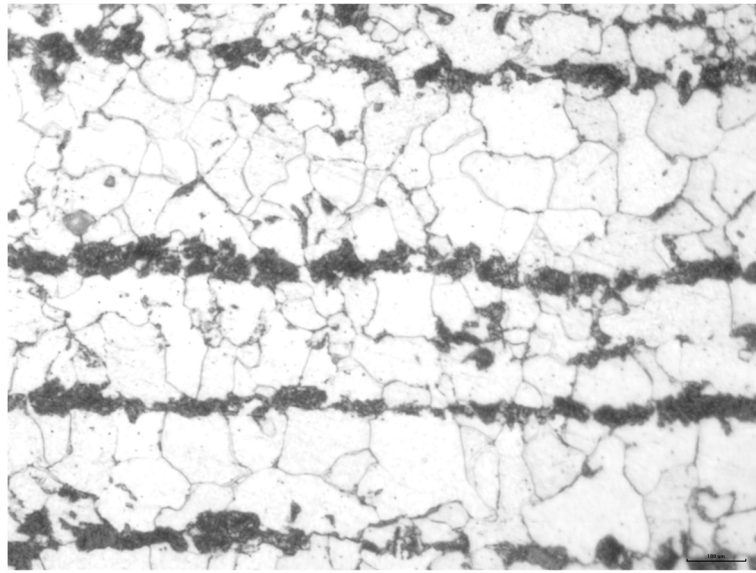
Fig. 31 Section 3 at the 3# crack (position ② in Fig. 28)
