Experimental and numerical analysis of rainfall-induced slope failure of railway embankment of semi high-speed trains

Mohammad Aqib¹, Shadab Usmani², Tanveer Khan³, Md Rehan Sadique^{1*}

Abstract

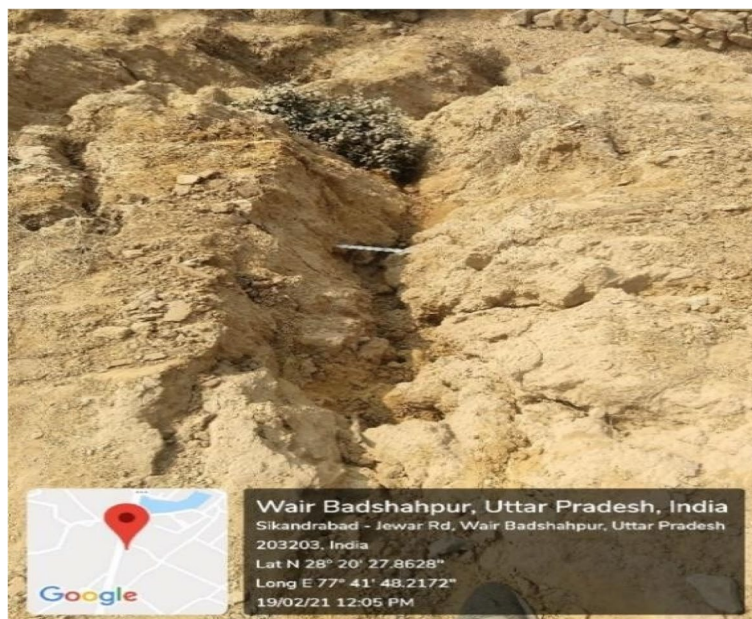
Fig. 3 Studied embankment at Wair, showing effect of gully and slope failure no 1

S. No	Features	Dimensions			
		Failure no. 1	Failure no. 2	Failure no. 3	Failure no. 4
1	Turfing	Not present	Not present	Not present	Not present
2	Length	15.0 m	4.0 m	15.0 m	3.1 m
3	Width	1.1 m	0.8 m	3.5 m	0.6 m
4	Depth	4.0 m	0.4 m	4.0 m	0.8 m
5	Failure Pattern	Inclined over slope	Straight	Inclined over slope	Zig-Zag

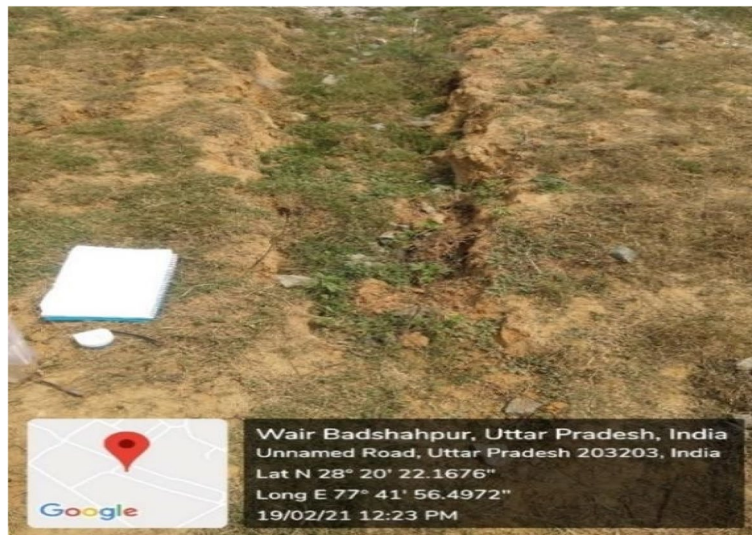
Fig. 4 Studied embankment at Wair, showing effect of gullying and slope failure no 2

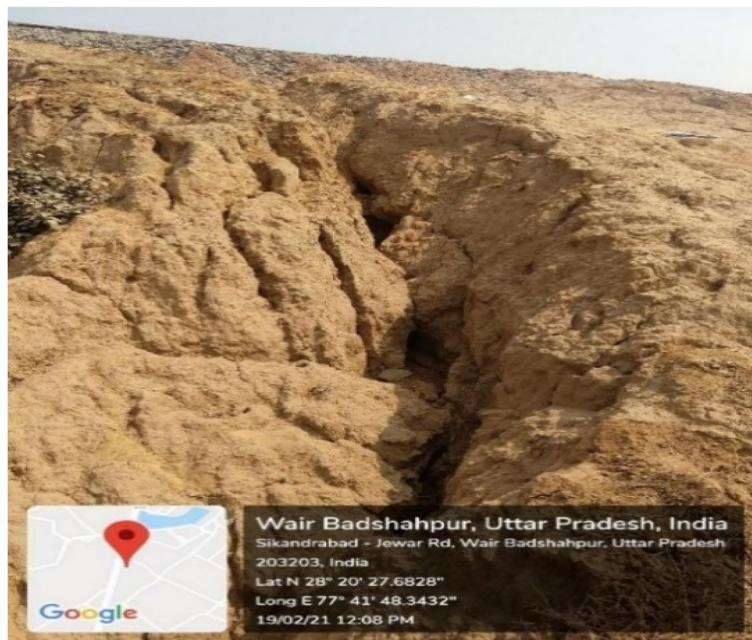
Fig. 5 Studied embankment at Wair, showing effect of gullying and slope failure no 3

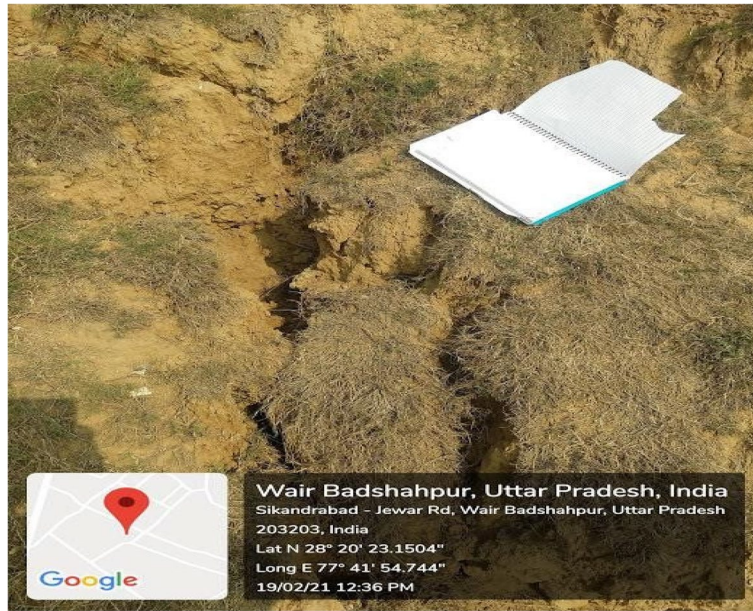
Fig. 6 Studied embankment at Wair, showing effect of gulying and slope failure no 4

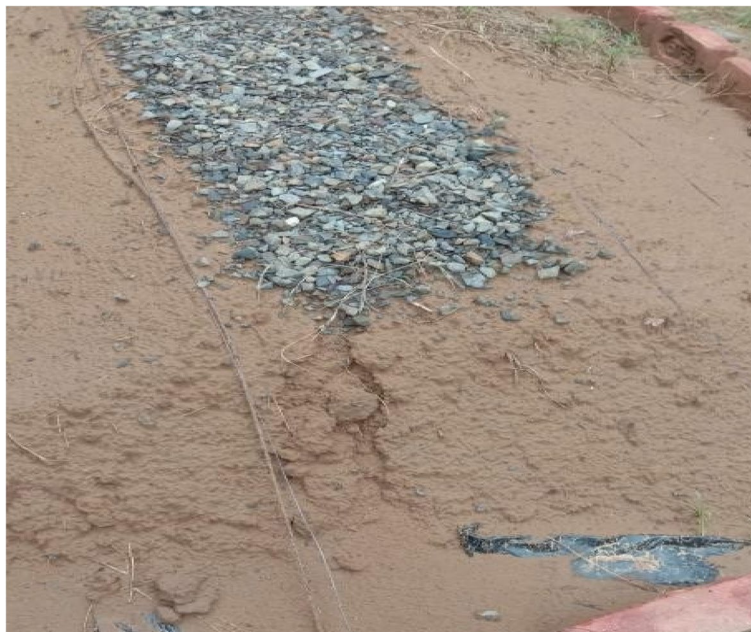
Rainfall amounting to 53 mm was recorded on the 20th of July which causes damage to the central less compacted part of the embankment. A gully of 4 cm width and 4 cm deep (named CG1) was observed as conveyed in Fig. 14. Merely after 2 days, i.e., 22nd of July, rainfall amounting to 68 mm was recorded. This rainfall proved fatal to the embankment as 6 more new gullies were formed. Two of them were on the left-hand side of the longitudinal slope (LG3 and LG4) as depicted in Fig. 15(a), and another two were formed on the right-hand side of the longitudinal slope (RG1 and RG2) as shown in Fig. 15b, while another two were observed on central less compacted part (CG3 and CG4) as depicted in Fig. 16. Dimensions of gullies were regularly recorded and updated from time to time as shown in supplementary documents. Continuous rainfall for

Fig. 14 Shows gully formation at less compacted central face of embankment

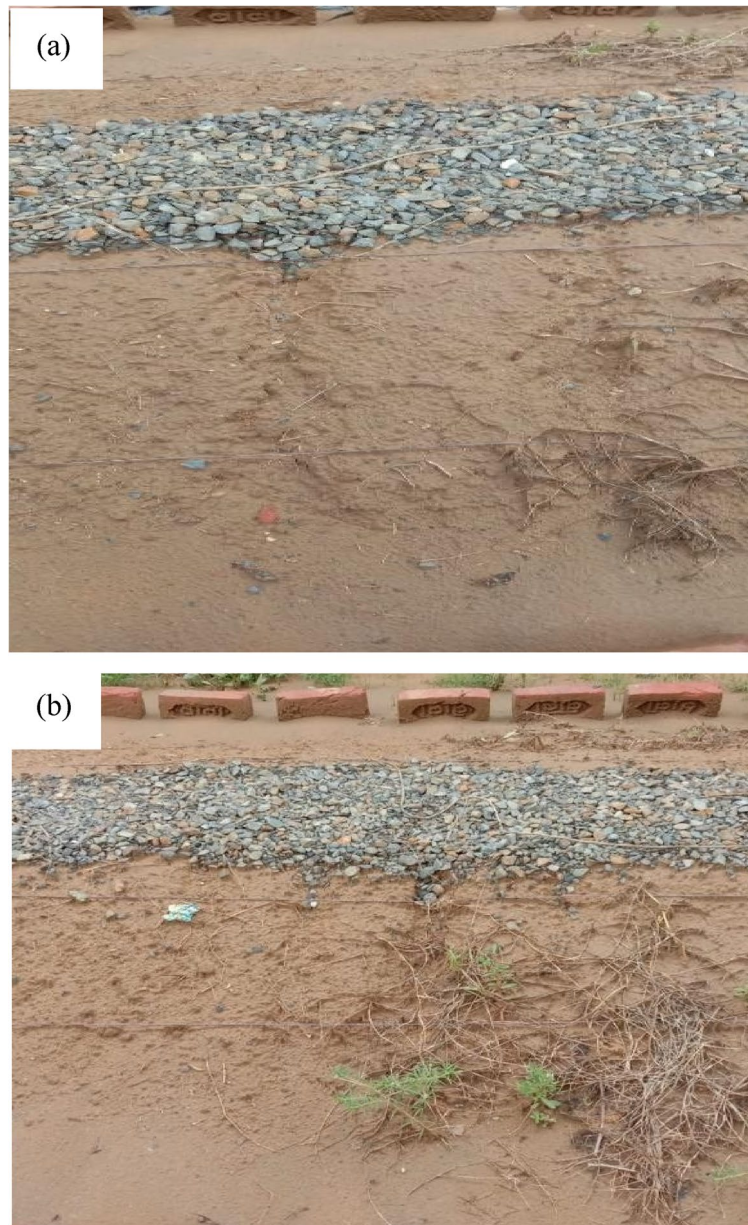
two consecutive days amounting to 54 mm was observed on the 27th and the 28th of July. This storm leads to the formation of another two new gullies (named as LG2 and CG2) as depicted in Fig. 17a, b. Little change was observed in the previous formed gullies. Another storm of 25 mm was recorded on the 29th and 30th of July which causes another two new gully formations (LG1 and RG3).

Fig. 15 **a** Conveying two new gullies on left side of longitudinal slope. **b** Conveying two new gullies on right side of longitudinal slope

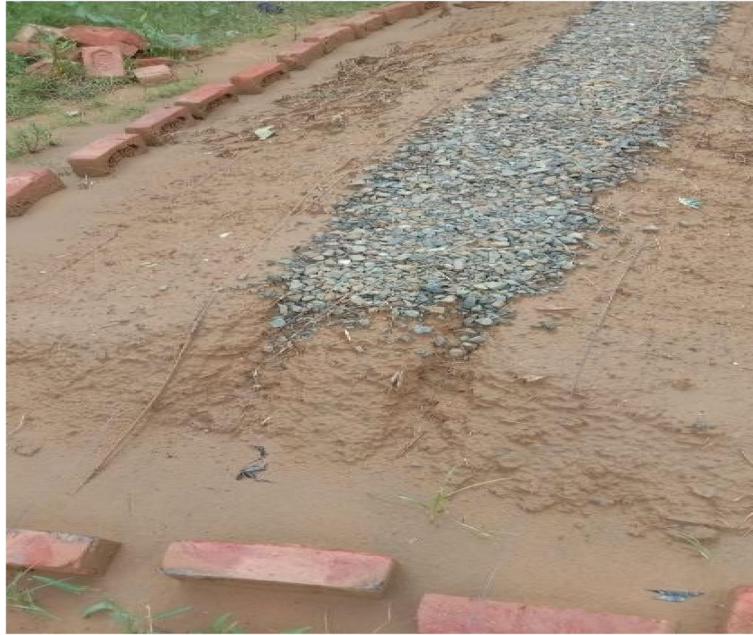
Fig. 16 Showing two newly formed gullies on lateral side

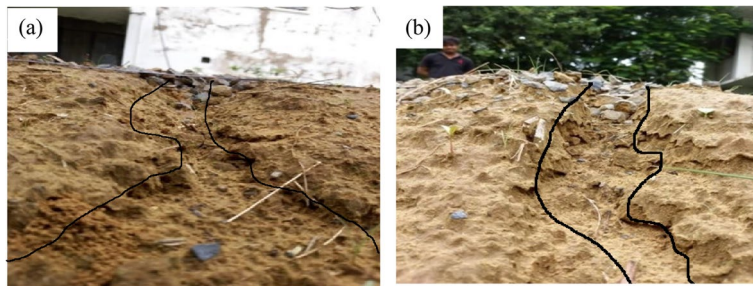
Fig. 17 **a** Depicting a new gully on left hand side of embankment. **b** Showing a new gully formed on less compacted central portion of embankment

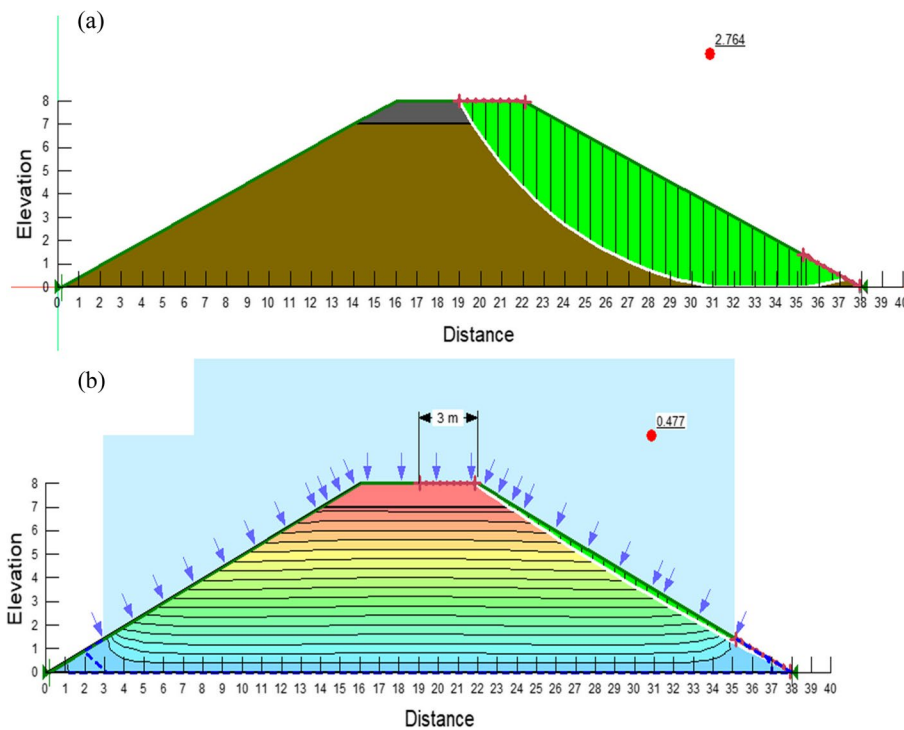
The stability of the embankment was tested several times in both dry and submerged conditions. The embankment was found to be stable using SLOPE/W analysis on GEO-STUDIO, with a factor of safety of 2.764, indicating a stable construction (as depicted in Fig. 21a). The seepage study of the model under $1.66E - 5$ m/s rainfall infiltration shows the formation of a critical surface near the sloping portion which demonstrates the possibility of surface failure/gully failure. The factor of safety registered by GEOSTUDIO under steady seepage conditions was 0.477 as shown in Fig. 21b.

Fig. 21 a FOS of embankment without rainfall. b FOS at RG1 with maximum rainfall

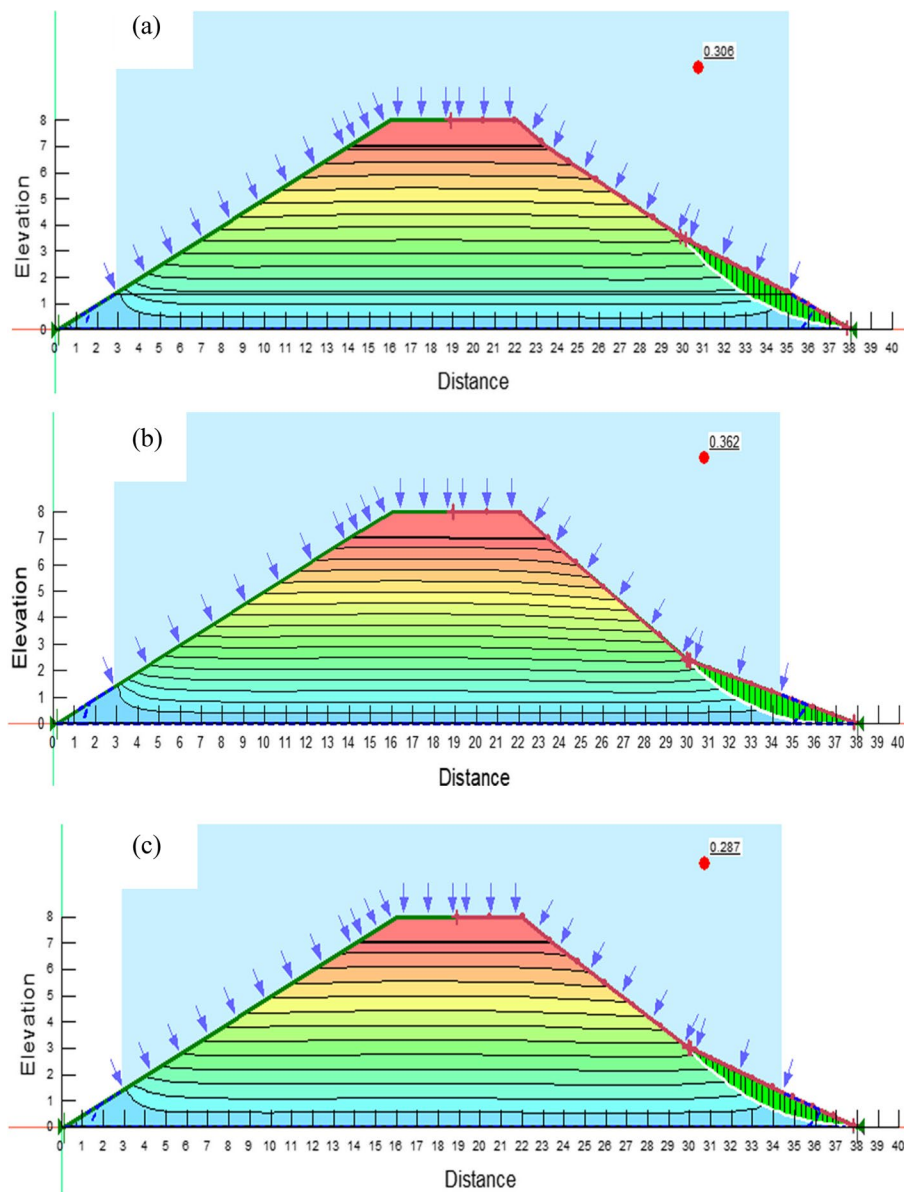
The initial 0.5 m gully occurred during the second rainstorm of intensity $1.88E - 05$ m/s, with a factor of safety of 0.306 recorded by GEO STUDIO as shown in Fig. 22a. Furthermore, additional rainfall with an intensity of $1.66E - 05$ m/s damages the embankment even more by causing 1.01 m gully. Using software, a factor of safety of 0.362 was found under steady seepage conditions which are depicted in Fig. 22b. After the occurrence of rainfall with an intensity of $2.20E - 05$ m/s, the greatest gully of 1.39 m was discovered. The software calculated a factor of safety of 0.287 in this instance as shown in Fig. 22c.

Fig. 22 **a** FOS at RG1 with 2 cm gully for 68 mm rainfall. **b** FOS at RG1 with 4 cm gully for 60 mm rainfall. **c** FOS at RG1 with 5.5 cm gully for 80 mm rainfall

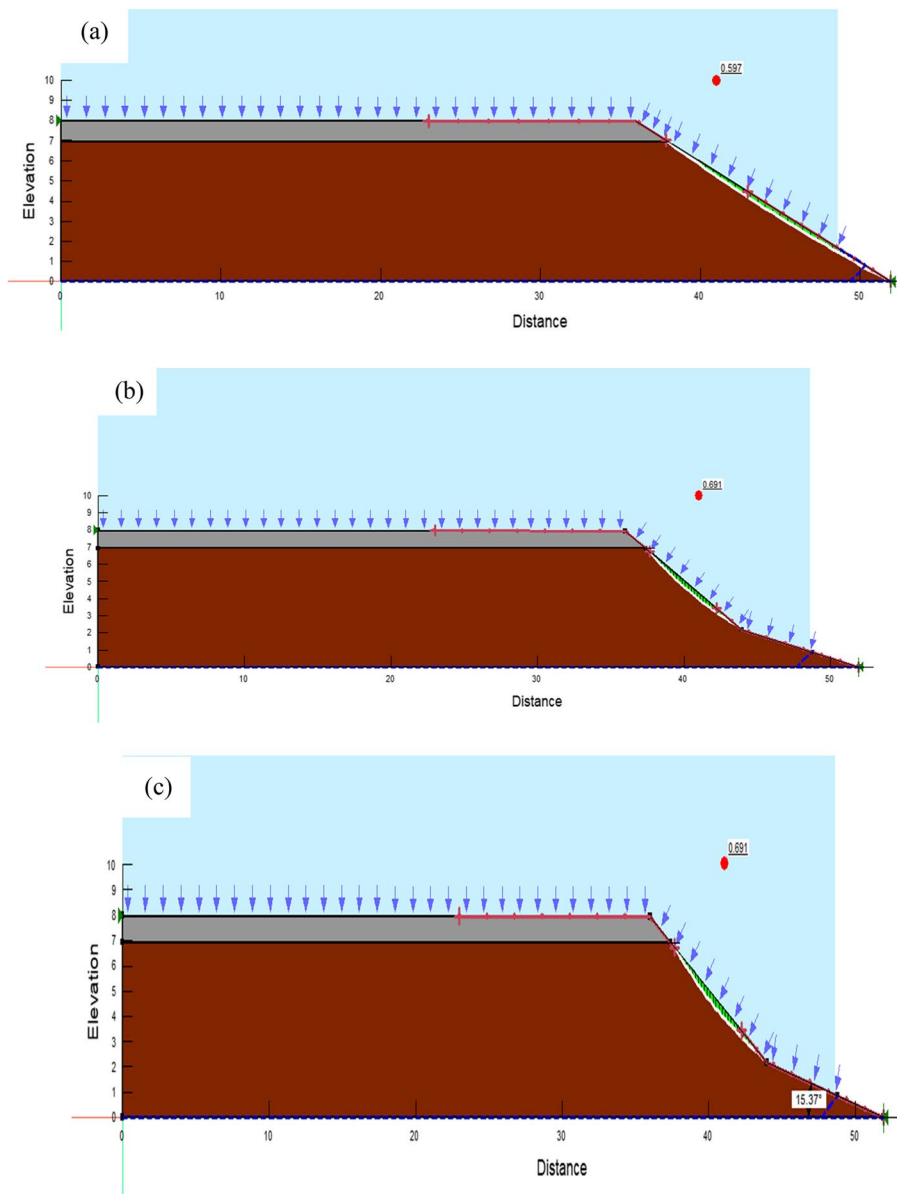
In this case, stability was checked for submerged conditions under the influence of maximum rainfall, i.e., 80 mm recorded during the entire period. The embankment was unstable as GEO-STUIDO showed up a factor of safety of 0.597 as shown in Fig. 24a. Moreover, the critical surface formed was nearby the top surface, indicating the proneness of this part of the embankment to shallow failure in the form of gullies.

The FOS registered by GEO-STUDIO for initial deformation of 1.52 m with rainfall intensity of $1.88E-05$ m/s was 0.691 as shown in Fig. 24b. The second storm which struck the lab model was just after 5 days and it changed the depth of gully to 1.773 m. After being analyzed through steady-state analysis, this gully which faced rainfall intensity of $1.5E-05$ m/s showed up the very same FOS as of the last case, i.e., 0.691 as shown in Fig. 24c. The third storm affected CG4 severely and caused the deformation of 3.04 m. The rainfall intensity for this storm was found to be $1.66E-05$ m/s. After performing analysis, the factor of safety got reduced by 11% to 0.610 as shown in Fig. 25a. Another

Fig. 24 **a** FOS of longitudinal section of embankment under the influence of maximum rainfall recorded. **b** FOS at CG4 with 7 cm gully for 54 mm rainfall. **c** FOS at CG4 with 7 cm gully for 54 mm rainfall

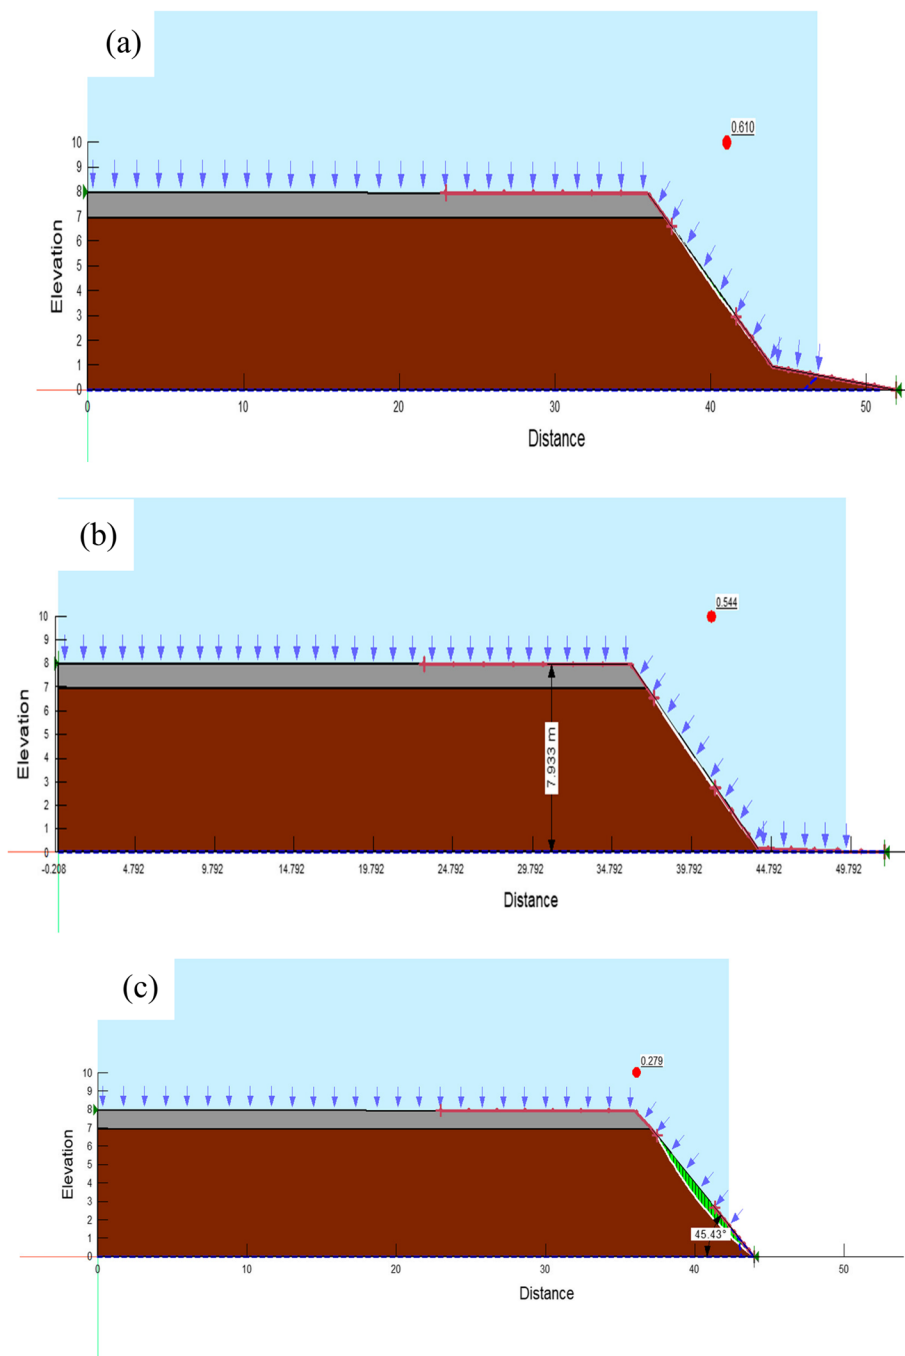
storm of intensity $2.2E - 05$ m/s deteriorate the slope further by increasing the depth of gully to 3.8 m. Slope stability analysis under steady-state analysis in GEO-STUDIO recorded a factor of safety of 0.544 as shown in Fig. 25b. The depth of the gully recorded was 4.81 m after the occurrence of previous rainfall and rainfall intensity observed in this storm was $1.66E - 05$. GEO-STUDIO shows a factor of safety of 0.279 for this case as shown in Fig. 25c. As compared to the last scenario, it can be said that FOS drops drastically this time by 54%. Since FOS was less than in each case, it can be concluded that the central part of the embankment (CG4) was not stable at all. Moreover, as the embankment was getting deformed under the effect of rainfall, and FOS was also getting reduced.

Fig. 25 a FOS at CG4 with 12 cm gully for 60 mm rainfall. b FOS at CG4 with 15 cm gully for 70 mm rainfall. c FOS at CG4 with 19 cm gully for 80 mm rainfall
