# Reconstruction and rehabilitation of the Grand Al-Nouri Mosque dated to the twelfth century: a case of study

This paper aims to present the structural design and the rehabilitation process as well as the site assessment of the reconstruction and rehabilitation of the twelfth-century Grand Al-Nouri Mosque in Al-Nouri Complex, which is a part of the project Revive the Spirit of Mosul in Iraq. UNESCO launched the project Revive the Spirit of Mosul in February 2018 in order to reconstruct the old city after the destruction and looting from the wars with ISIS (Daesh) in 2017. Al-Nouri Complex includes the Great Al-Nouri Mosque and the 45-m-high Al-Hadba Minaret, which are the iconic historic landmarks of the old city of Mosul on the western side of the Tigris River, and it was built by Nur Al-Din Zengi during the twelfth century. Al-Nouri Mosque was reconstructed in 1942 using the original 40 octagonal Moslawi marble columns, and alabaster arches, the mihrab brought from the Ummayad Mosque in Mosul dates back to 956 AD, masonry stones, and a reinforced concrete roof. In this paper, the structural performance of Al-Nouri Mosque has been investigated through site observations, experime

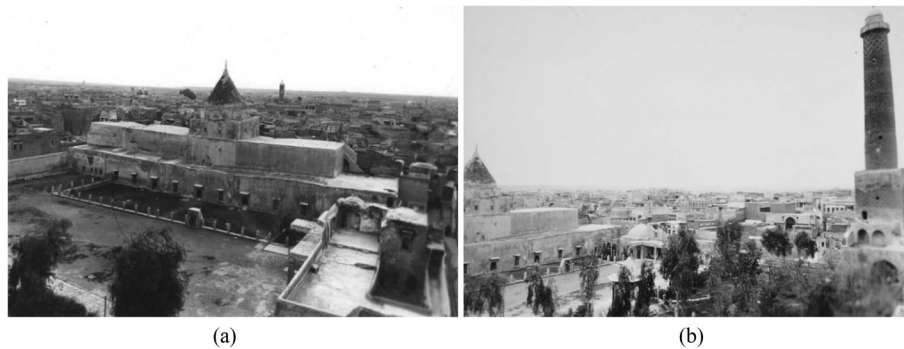
**Fig. 2** The Grand Al-Nouri Mosque before reconstruction in the 1940s [1, 20]. **a** The view of the old prayer hall. **b** The front view of the old prayer hall accompanied by the school and courtyard mihrab

The twelfth-century mosque prayer hall is not documented, and the design evaluation of the prayer hall reflects its aesthetic assets. In the period between 1211 and 1259 AD, the hall presented a hypostyle structure with Moslawi marble octagonal columns and inscribed capitals. A 16-faceted conical dome was surmounting the Qibla wall, ornamented with stucco. Moreover, a mihrab, built during this period and supposed to have been inside the prayer hall, was moved to the courtyard. Afterward, in 1869, the structure was consolidated with internal walls and additional columns. Also, another mihrab dated to 956 AD was brought from the Ummayyad mosque in Mosul and placed earlier in the west wing. Formerly, the building was composed of two rectangular prisms varying in height; a faceted dome placed on an octagonal form topped the higher prism. The plan layout of the prayer hall was 13 bays in length and 1.50 bays deep. Figure 2 presents the prayer hall before the reconstruction in the

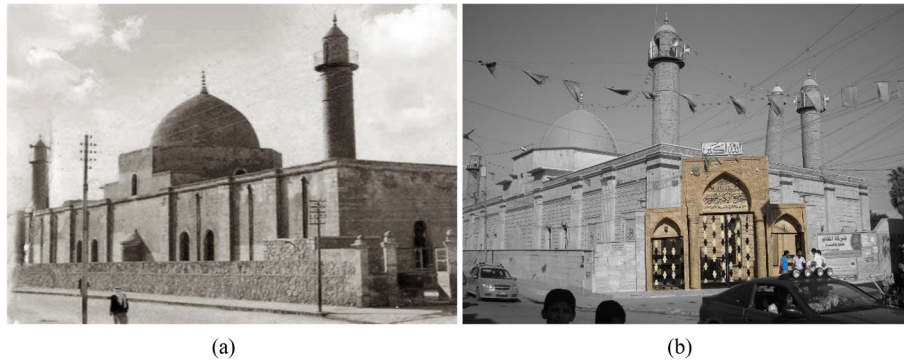
**Fig. 3** The Grand Al-Nouri Mosque [21]. **a** Before 1990. **b** After 1990

1940s. On the other hand, in the period between 1944 and 1950, the new prayer hall presented a different design with a rectangular hypostyle structure with 40 octagonal Moslawi marble columns, as shown in Fig. 3. A dominant hemispherical dome that covers the central bay opposite the mihrab and rested on octagonal and square prisms, respectively. The hall was covered with a flat roof and constructed of stone masonry and reinforced concrete. The preserved elements from the prayer hall were twenty-four octagonal columns with decorated capitals, the mihrab of the Umayyad Mosque, which was placed in the middle of the Prayer Hall, and four rectangular columns with Lyre capitals, which became columns of the mihrabs in the west and east wings, as shown in Fig. 4. The layout of the building was five bays in length and 1.50 bays deep, with an added portico of another 0.50 bays deep on the northern facade. The octagonal columns supported high pointed alabaster arches and exhibited short friezes on their capitals, previously formed parts of continuous Quranic verses, but mid-twentieth century intervention had disturbed the original sequence. Further decorative elements appeared over the central mihrab, such as a calligraphic cartouche with the inscription for the building's date and patron's name. The entrance inside the hall was made through three semi-circular doors situated on the northern facade, under the portico. The interiors were lit up through a series of semi-circular arched windows with keystones. The northern and southern facades included four windows, while the eastern and western elevations comprised three windows. However,

insignificant alterations occurred by the 1990s; the initially simple facades covered by the local limestone (Al-Hillan) with no decorations were later replaced with the same type of stone, but this time with tiles of different dimensions and textures. Pillars representing the interior hypostyle structure enlivened the southern, western, and eastern facades. The same facades were decorated with square panels with circular medallions, containing some of the 99 names of Allah. Horizontal strips of green ceramics and a top strip in stone with Arabic writings from the Quran wrapped around the building from the three sides [1, 17–19].

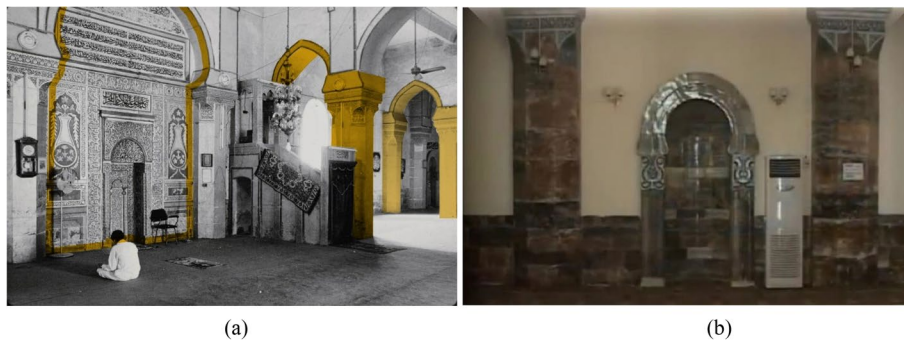
**Fig. 4** Interior of the prayer hall in the Grand Al-Nouri Mosque [20]. **a** Octagonal columns with decorated capitals and the Umayyad mihrab. **b** Mihrab with Lyre capitals in the two wings

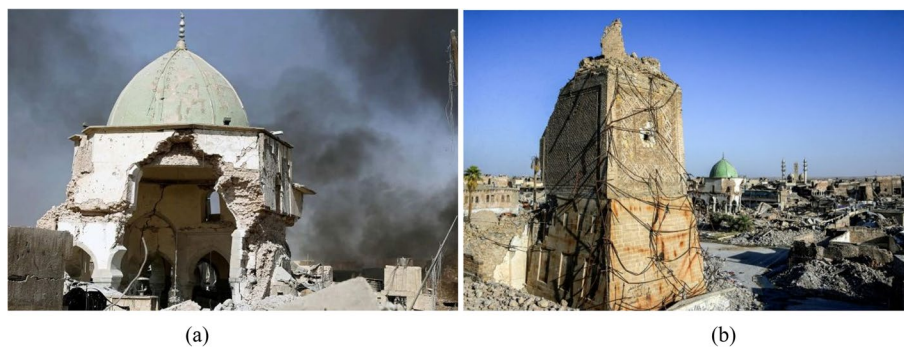
**Fig. 6** The Grand Al-Nouri Mosque after the blasting of the explosive placed by Daesh fighters [25]. **a** The mosque prayer hall. **b** Al-Hadba Minaret

liberation, intended to destroy the complex's two famous landmarks: Al-Nouri Mosque and the Al-Hadba Minaret, as shown in Fig. 6. The minaret lost its entire cylinder-shaped shaft with the lantern and the balcony; only the two bases are still standing. The structure adjacent to the minaret on its eastern side had been exposed to significant fractures across the remaining walls and vaults. Nonetheless, the prayer hall retained only the central dome, parts of the south walls and the Ummayyad Mihrab, a few Moslawi marble pillars, and a limited portion of its eastern sector. Part of the surviving structures under the dome appear in a bad state of conservation. The dome's southwestern pillar collapsed, while its other remaining ones are visibly rotated. Furthermore, the western wing, the portico, and all the external walls were destroyed. Extensive losses occurred in the masonry of the octagonal prism, thereby leaving the remaining portions in an unstable situation.

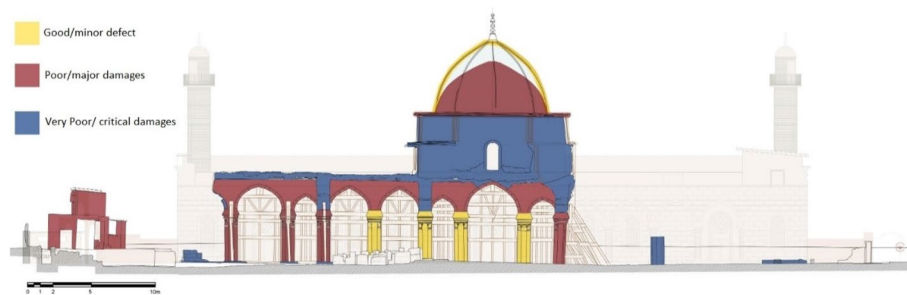
**Fig. 7** Illustration of the grand Al-Nouri Mosque complex condition after the war

According to the visual site investigation, the current dome is a double dome consisting of two masonry domes: a lower circular dome and a tamped conical upper dome with vertical ribs that are supported on the lower one. The two domes are supported on a ring RC beam, and this beam is placed on the masonry walls above the arches to form the square base of the dome with the qibla wall; at a height of 10 m from the ground, the transition area consisting of muqarnas begins, and these muqarnas have transformed the square shape to an octagon, and the octagonal base is surmounted by a circular base, serrated in shape, on which a stucco-built dome rest. It is decorated, and to protect the inner dome from weather factors, the outer conical dome has constructed the polygon, which is relatively high, is not comparable to any other dome in Mosul, and has 16 faces. It is built with bricks, its height is 15 m, and it is close to the pyramidal shape. In addition, Arches in the prayer hall were built using the local alabaster tiles (Moslawi marble), which is named Alfarsh, to form the arch, and masonry stones were built above these tiles. These arches are supported on the pillars of the mosque which are from local alabaster (Moslawi marble). The damage and the visible defects of the Mihrab, pillars, arches, and domes are summarized in Table 1 and are shown in Figs. 7 and 8. At the end of 2019 and after the war of liberation of Mosul, UNESCO started a project for the execution of safety stabilization measures inside the site of the Al-Nouri Complex which included Al-Nouri Mosque and Al-Hadba Minaret [25], as shown in Fig. 8. This project was conducted using the

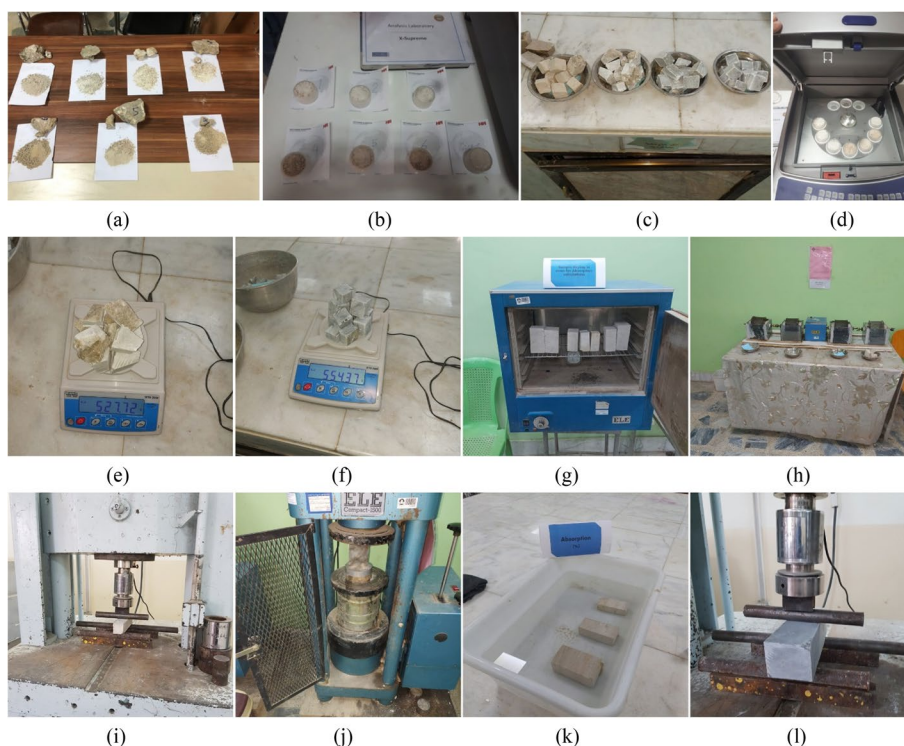
**Fig. 14** Experimental tests for the samples of the old materials used in the construction of the mosque

To evaluate the actual mechanical properties of the original stones and Moslawi marble that will be used in the reconstruction of the mosque, an experimental investigation of these old materials was conducted after getting approval from UNESCO and the Iraqi State Board of Antiquities and Heritage. The original investigated materials included the Moslawi marble used in columns, the stones used in the foundation, and the mortar between the stones of the foundation, as shown in Fig. 13. This experimental investigation was conducted using three samples of each type that was selected from the original damaged parts of the mosque and tested by the Laboratories of Engineering College, University of Mosul, as shown in Figs. 13 and 14. Also, the physical and XRF-minerals experimental tests of the original footing stones and Moslawi marble samples were conducted, as shown in Fig. 14. The flexural test was conducted on specimens with the dimension of  $100 \times 100 \times 400$  mm, and the compressive test was applied to specimens with the dimension of  $100 \times 100 \times 200$  mm. On the other hand, high-strength stainless steel tie rods and sections with durability characteristics not inferior to those corresponding to AISI 304/316L will be used for the strengthening of the remaining elements such as the Moslawi marble columns and stone foundations. The reinforcement steel bars in the reinforced concrete elements of the new roof and columns were with grades 420/600 and 280/450 for the longitudinal reinforcement and stirrups, respectively. The required compressive strength of concrete ( $f_{cu}$ ) for the design process was 20 MPa for the plain concrete, 40 MPa for RC columns and shear walls, and 35 MPa for the RC foundations and slabs. To evaluate the mix proportions of the RC concrete elements, a mix design was conducted, and six 150-mm standard concrete cubes for each mixture
