Failure analysis of weld cracking of gas gathering pipeline in dewatering station

Yong Chen^{1,2*}, Yi Xie¹, Wenjing Wang³ and Jichuan Li⁴

Keywords: Gas gathering pipelines, Weld, Failure analysis, CFD simulation

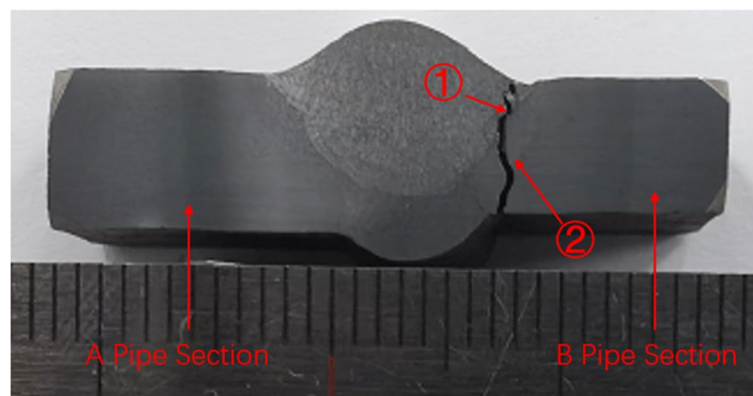
Fig. 14 Equivalent stress distribution at different weld heights

According to the steel pipe welding executive standard “GB/T31032-2014 *Welding and acceptance standard for steel pipings and pipelines*,” the weld is set to have a smooth transition with the base metal, and the welding bevel is 65°. Under the condition that the girth weld has no misalignment, the cover weld height is 2mm, and the pipeline operating pressure is 2.83MPa; the root weld heights are set to 2mm, 3mm, 4mm, and 5mm, respectively; and the stress distribution of the welded joints is analyzed. As can be seen from Fig. 14, the greater the root weld height, the more severe the degree of stress concentration. The direction of fluid flow is from the B pipe to the A pipe, which also confirms from another perspective that the maximum stress-strain and cracks always appear at the weld near the side of pipe B.

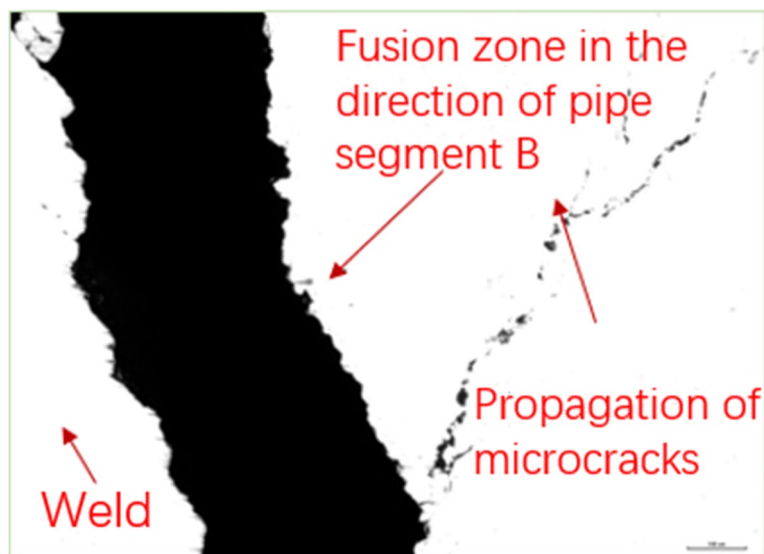
According to the data provided, since the pipeline has been put into operation for 2 months, the fluctuation range of the actual operating pressure is not very large, so the pressure fluctuation range is set to 1MPa in this analysis. Through the weld quality

Fig. 16 Equivalent stress distribution under different operating pressure conditions

inspection, the maximum root weld height of the ring weld pipe is 4.6 mm. In order to further analyze the impact of fluctuations in actual operating pressure on the welded joint, a pipe model with a root weld height of 4.6 mm was established, and the flow-solid coupling analysis was performed under the operating pressure conditions of 2.83 MPa, 3.33 MPa, and 3.83 MPa, respectively. As can be seen from Fig. 16, the operating pressure fluctuations have a significant impact on the stress of the welded joint, with the increase in operating pressure, the stress of the welded joint increases, and the degree of stress concentration becomes more and more serious. On the basis of the influence of the weld height, the formation of cracks will be accelerated.

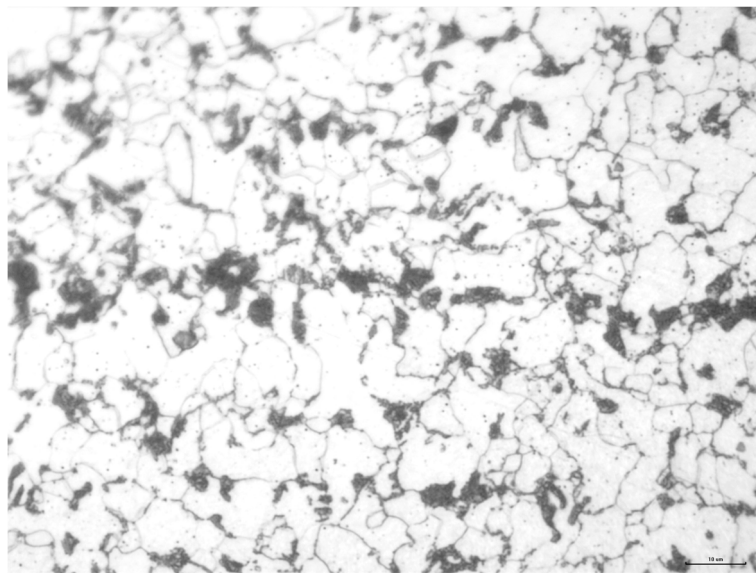
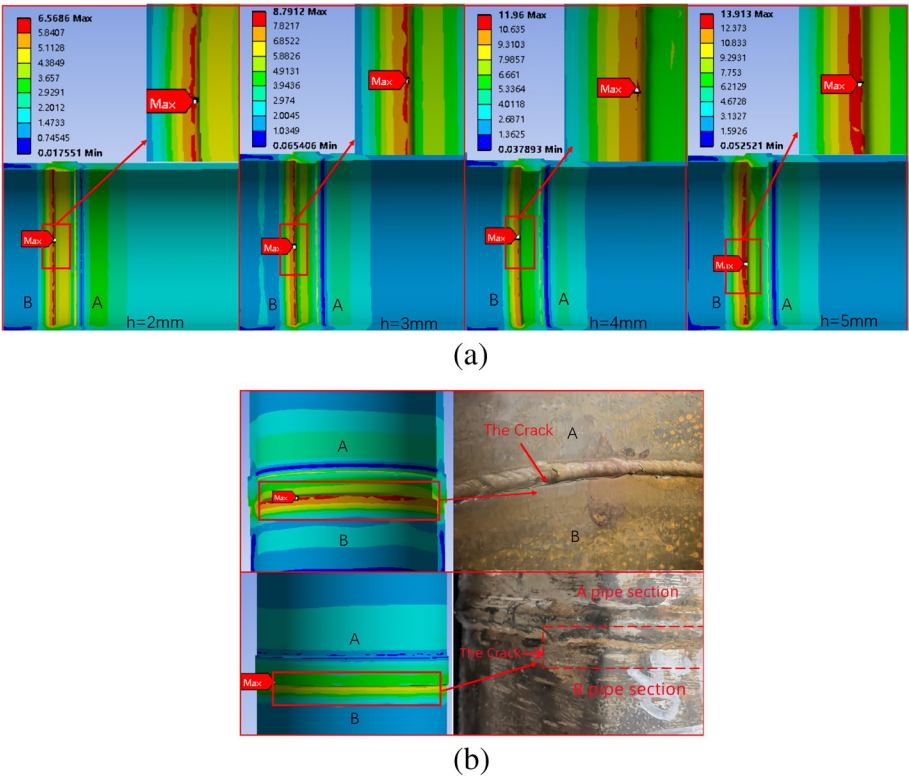
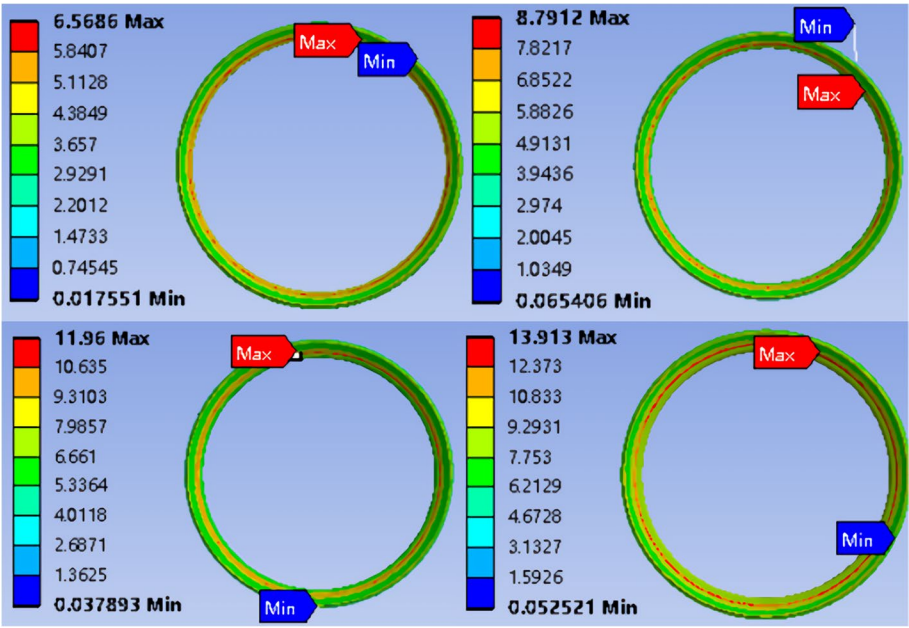
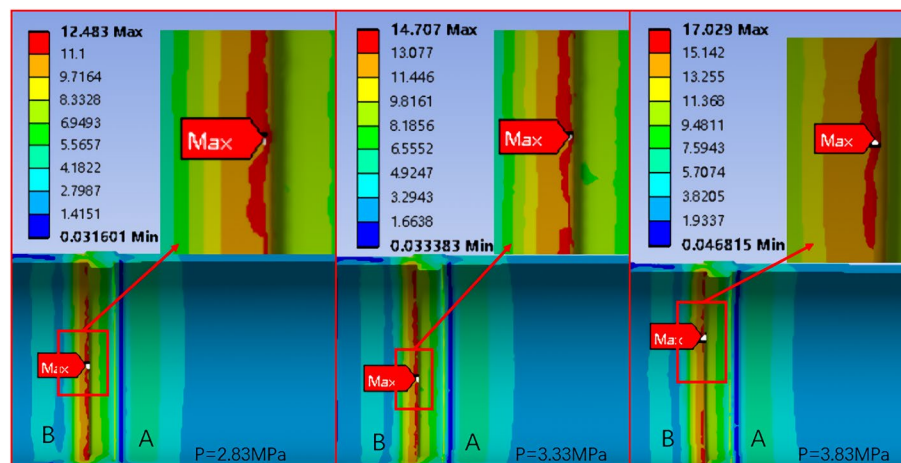
Item\number	Metallographic structure	Grain size	Inclusions
A pipe section	PF+P (Figs. 32 and 33)	11	D2.5
B pipe section	PF+P (Figs. 34 and 35)	11	D2.5

One specimen was taken from the A and B pipe sections near the cracking position of the failure girth weld for metallographic analysis. The results show that the base metal of the steel pipe is a multilateral ferrite structure, and the crack is located in the weld, close to the fusion boundary on the one side of the B pipe section. The microstructure of the weld near the crack is the same as that of the girth weld. The analysis results are summarized in Table 13.
