Experimental and numerical analysis of rainfall-induced slope failure of railway embankment of semi high-speed trains

Mohammad Aqib¹, Shadab Usmani², Tanveer Khan³, Md Rehan Sadique^{1*}

Abstract

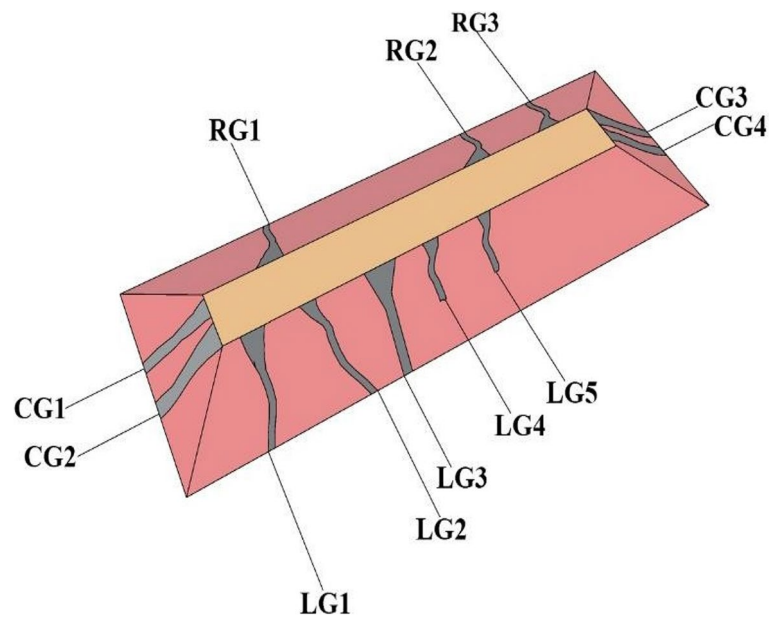
Details of the gullies formed after every rainfall was recorded and was named to make our study informative and easy to understand for the one going through it. Names given to the gullies formed are illustrated in the following animated 3D figure as shown in Fig. 11.

Fig. 11 Illustration of the embankment showing the final gullies after one rainy season

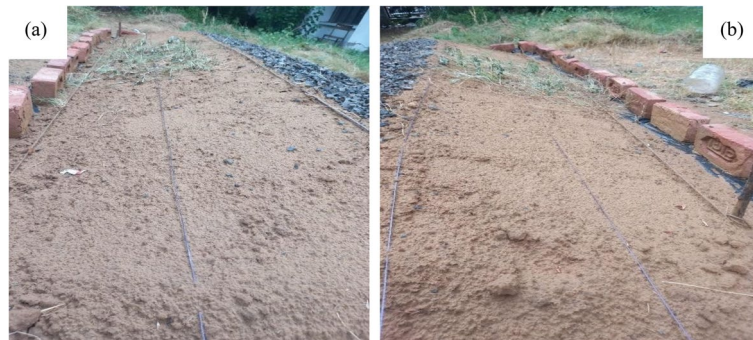
On the 12th of July, light rainfall of 4.4 mm was observed to which our embankment showed perfect resistance which is obvious from Fig. 12a, b. Another rainfall of 3 mm was observed on 17th July, and the response of the embankment remains the same as shown in Fig. 13.

Fig. 12 a, b Depicting perfect resistance shown up by embankment against gullyng

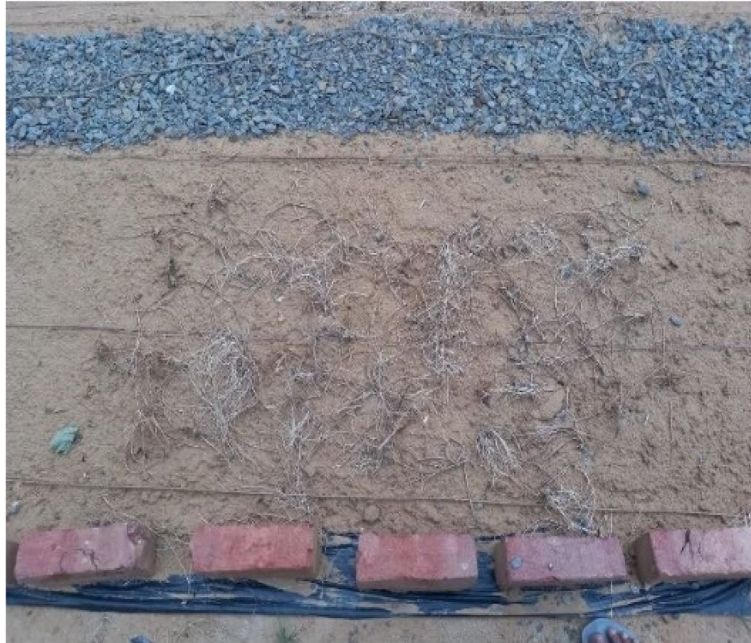
Fig. 13 Depicting no gully formation even after second rainfall

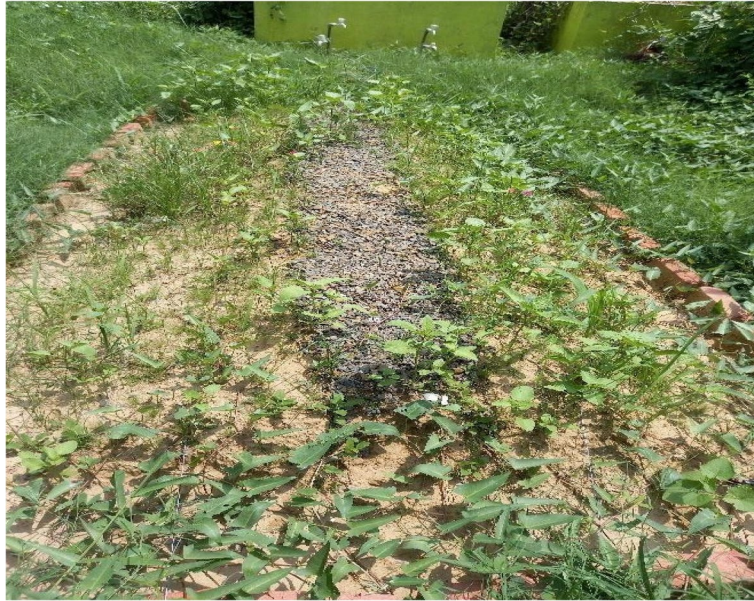
Little rainfall of 4 mm on the 2nd of August was observed which causes little change in previously formed gullies. A significant amount of vegetation was observed as depicted in Fig. 18. A very light intensity of rainfall was observed on the 20th and 21st of August and was unable to change the dimension of the embankment. Rainfall amounting to 60 mm on the 31st of August was observed and was unable to distort the configuration of the embankment. Significant vegetation cover was observed on the 31st of August as shown in Fig. 19. Continuous rainfall amounting to 80 mm during the 2nd and 3rd of September was recorded which causes very little or no change

Fig. 18 Shows growth of vegetation on embankment

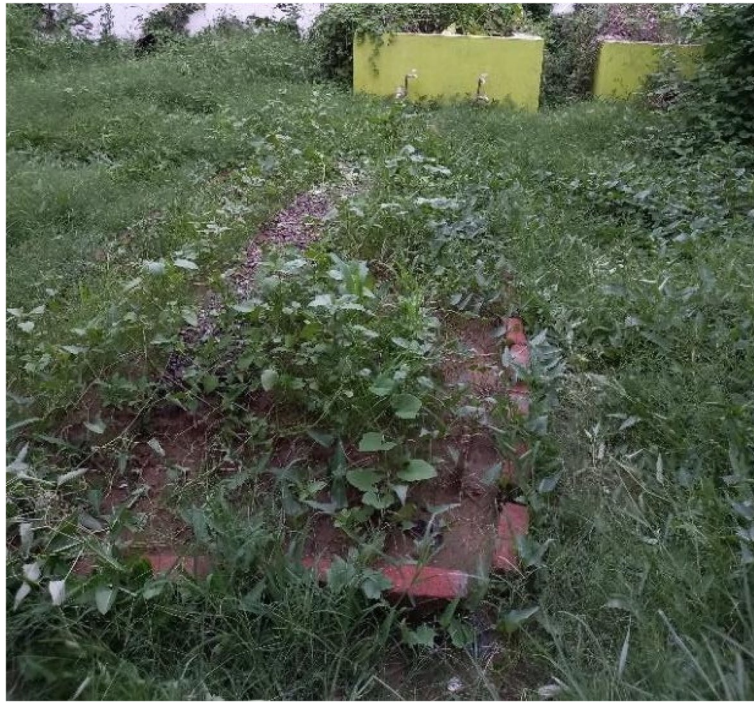
Fig. 19 Shows significant cover of vegetation over embankment

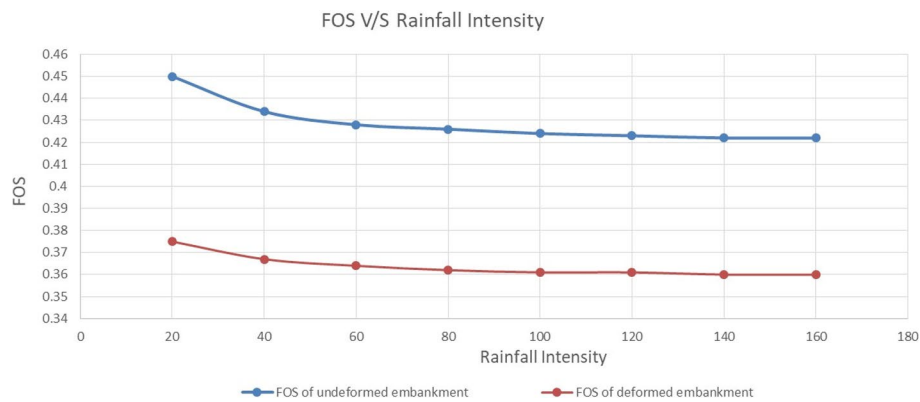
Through software simulation, the effect of increased rainfall intensity on FOS of the highest reported gully (1.39 m) of the embankment and undeformed embankment was also evaluated. FOS showed a decreasing tendency as rainfall intensity rose for both cases which are clearly visible in Fig. 23. However, as the intensity of rainfall increased, the decremental decrease in each iteration decreased. FOS was 0.375 at a rainfall intensity of 20 mm/h, dropping to 0.360 at 160 mm/h for deformed gully. Similarly, for the original embankment, FOS at 20 mm/h was observed as 0.45 which drops to 0.422 at 160 mm/h.

Fig. 23 FOS variation over the deformed and undeformed by varying the rainfall intensity
